LONG RIDGE DAM

NDI I.D. NO. PA-01022
PENNDER I.D. NO. 52-185

PHASE I INSPECTION REPORT
NATIONAL DAM INSPECTION PROGRAM

SEPTEMBER 1981

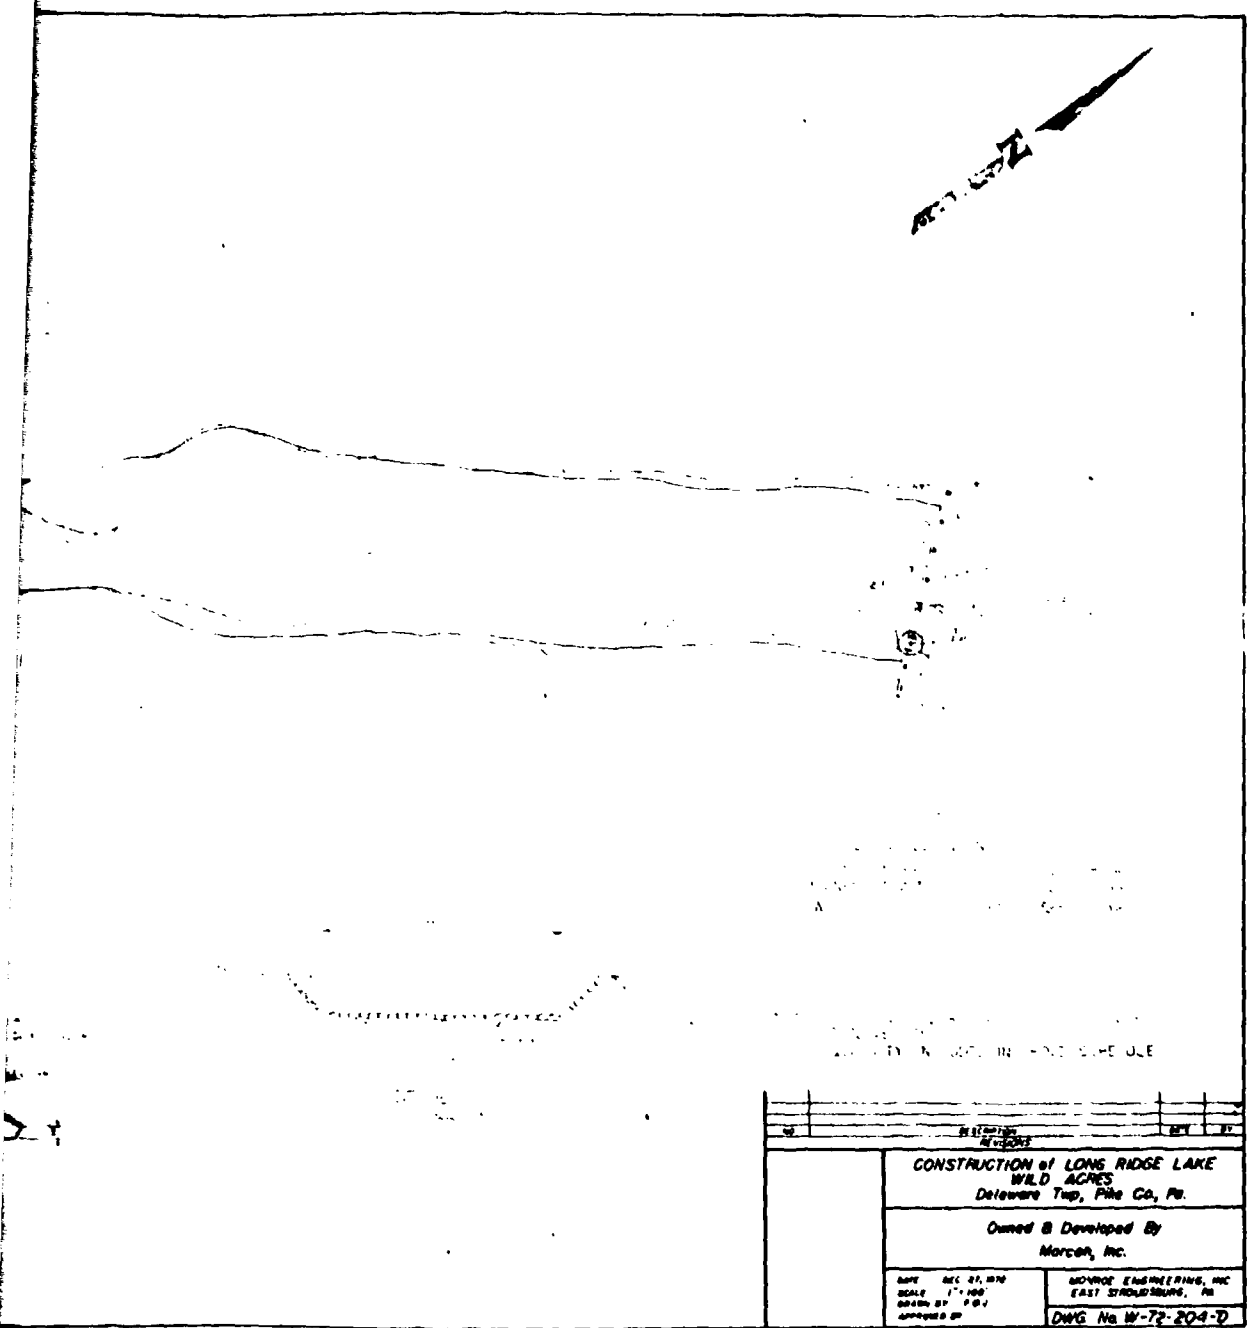
DISTANCE FEET	
CONSTRUCTION of LONG RIDGE LAKE WILD ACRES Delaware Top, Pike Co., Pa.	
Owned & Developed By Morcon, Inc.	
DATE DEC. 27, 1970 SCALE 1" = 100' DRAWN BY P.O. APPROVED BY	ADVANCE ENGINEERING, INC. EAST STRONGSBURG, PA. DWG No W-7p-204-D

1. Embankment. Based primarily on visual observations and field measurements, and with respect to the information detailed in Figure 2, general statements can be made regarding the embankment design. The dam is a 12-foot high, 350-foot long embankment, including spillway. As indicated, the structure is composed of homogeneous earth with a rectangular shaped cutoff located along the embankment centerline. The embankment crest and slopes are grass covered. Figure 2 roughly depicts the structure in both plan and cross section. It is noted, however, that the dimensions illustrated in the figure do not consistently correlate with those gathered by the inspection team. Field measurements indicate the upstream and downstream embankment faces are sloped at 2H:1V and 3H:1V, respectively, and the embankment crest is roughly eight feet wide. Some rock slope protection has been provided at the water line along the upstream embankment face (see Photograph 4).

There is no formal information available relative to the design and construction of this facility other than that contained in Figure 2. The embankment design, based solely on external appearances, generally conforms to the criteria established in modern engineering practice. The spillway, on the other hand, is cut directly through the embankment, but, is not lined with non-erodible material. This is considered to be a significant design deficiency that potentially threatens the stability of the entire structure (see Section 6.1.b.1).
